# Manhole Inspection Summary

Manhole # S63C1\_003MH

Insp Date: **3/4/08 1:30 PM**

**Location** Address: **5200 Vail St.**

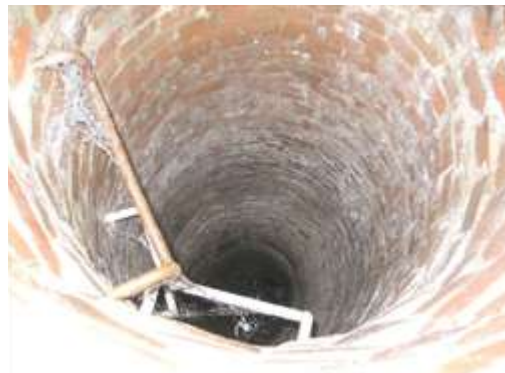
Top View

Can not remove cover or move it far enough to get a proper top view shot.

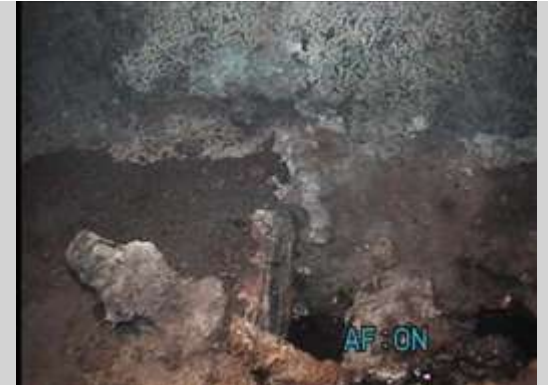
12 O'Clock Outflow

12 in. Circular Gravity Sewer  
Pipe Out @ 12 O'Clock

Deposits: ☐ None ☐ Mud ☒ **Sludge** ☒ **Debris** ☐ Grease

Silt Depth: **10.5** (in.) Deposits Extent: **Heavy**

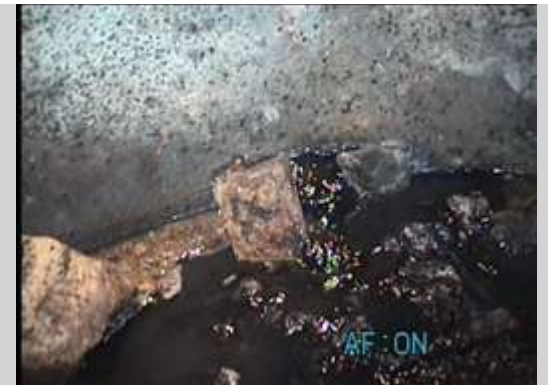
6 O'Clock Inflow

12 in. Circular Gravity Sewer  
Pipe In @ 6 O'Clock

Deposits: ☐ None ☐ Mud ☒ **Sludge** ☒ **Debris** ☐ Grease

Silt Depth: **8** (in.) Deposits Extent: **Heavy**
